NATIONAL COMMUNICATIONS AUTHORITY

3G Coverage Assessment of Cellular Mobile Services- Ashanti Region

[September 2016]

**3G COVERAGE ASSESSMENT OF CELLULAR MOBILE SERVICES IN ASHANTI REGION, –
SEPTEMBER 2016**

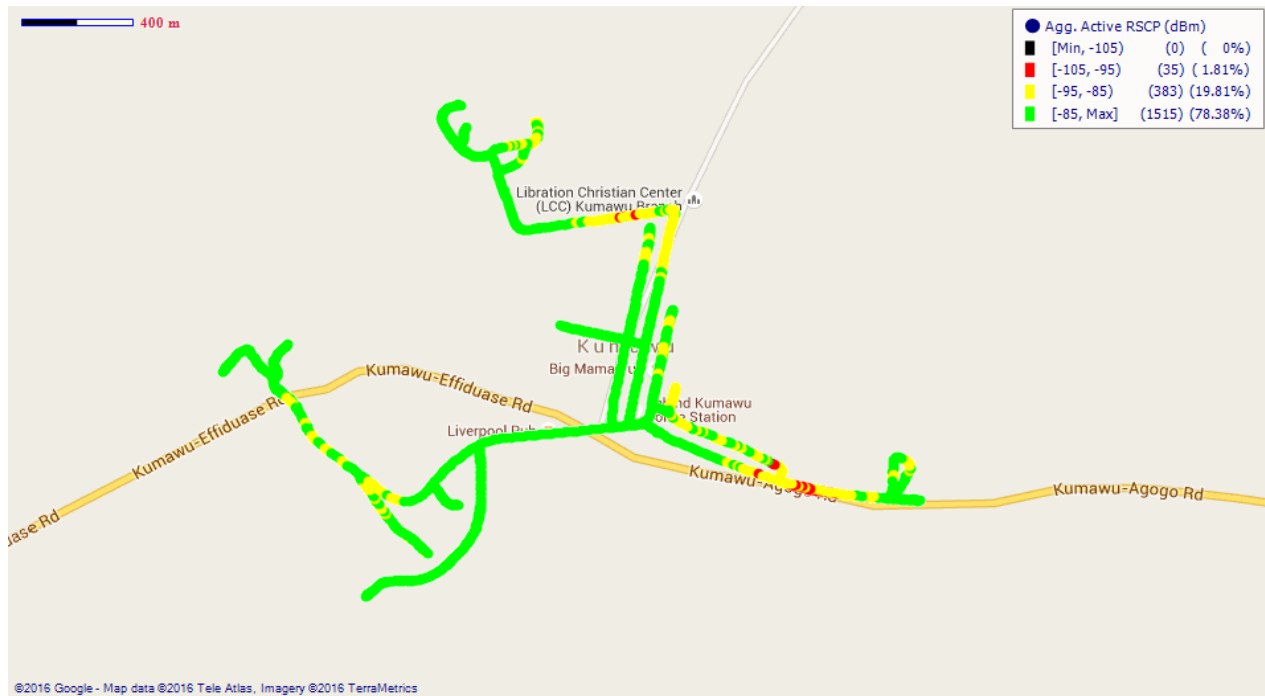
Fig. 71 - Vodafone 3G Coverage Map, Kumawu – September 2016

Remarks: Good 3G network coverage at Kumawu.
